Minerals Inspection Report

07/15/2014 Report Date: Mine Name: Torrey Buff South Mine Status: Permit Number: S/055/0022 Active Operator Name: Quality Building Stone 07/10/2014 Permit Fees: Paid Inspection Date: Inspector(s): Wayne Western Inspection Time: **Bond Amount:** \$14,000 Attendee(s): John Reay (BLM) Lyman (employee) Weather: **Bond Escalation:** 01/12/2009 Inspection Purpose: Routine inspection 05/22/2013 Prior Inspection: **Conclusions and Recommendations** The Operator needs to post additional bond. Evaluated & Commented Enforcement **Elements of Inspection** Permits, Revisions, Transfer, Bonds X Permit fee has been paid, change status from suspended to active 2. Public Safety (shafts, adits, trash, signs, highwalls) X There are highwalls on site. The highwalls are approximately 8 feet tall. 3. Protection of Drainages/Erosion Control **Deleterious Material** There was trash on site. In addition there were two large blue barrels with fuild in them. The Operator should place the large barrels in a spill prevention facility. Roads (maintenance, surfacing, dust control, safety) Reclamation

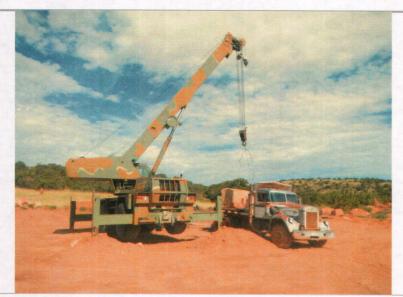
Load out area.

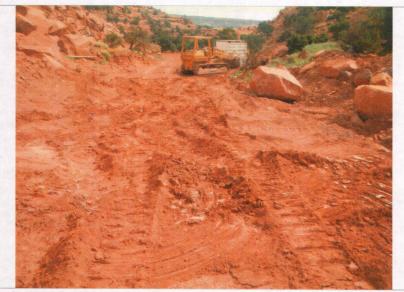
Dozer working area.

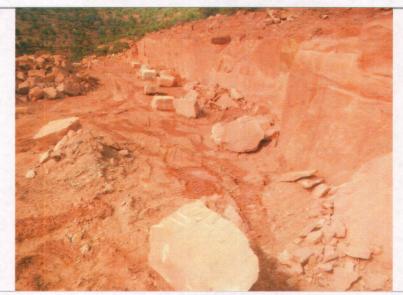
Highwalls

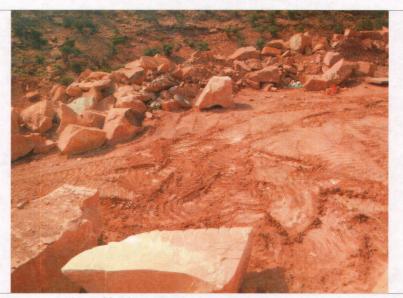
Working area - note tire and bucket
